Windstorm Mitigation Report (OIR-B1-1802)

Capri Isle Garden Apartments No. 1

250 126th Ave, Units 101-110, 201-210

As of 10/23/2023 | FPAT File# MUD2321231

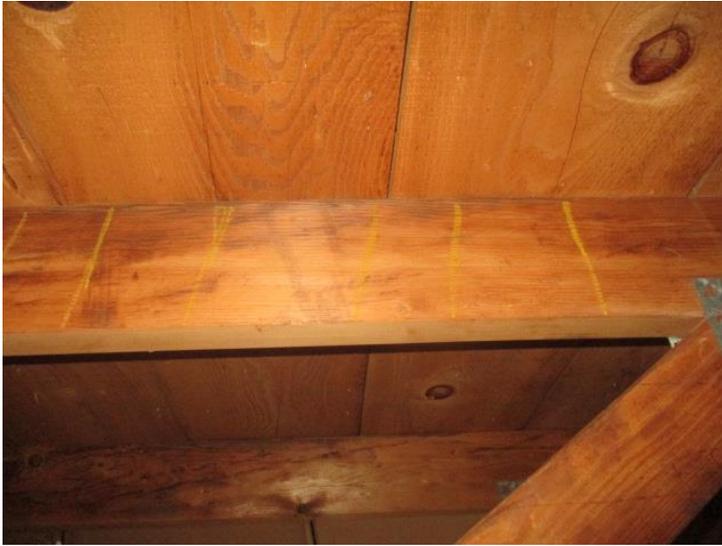
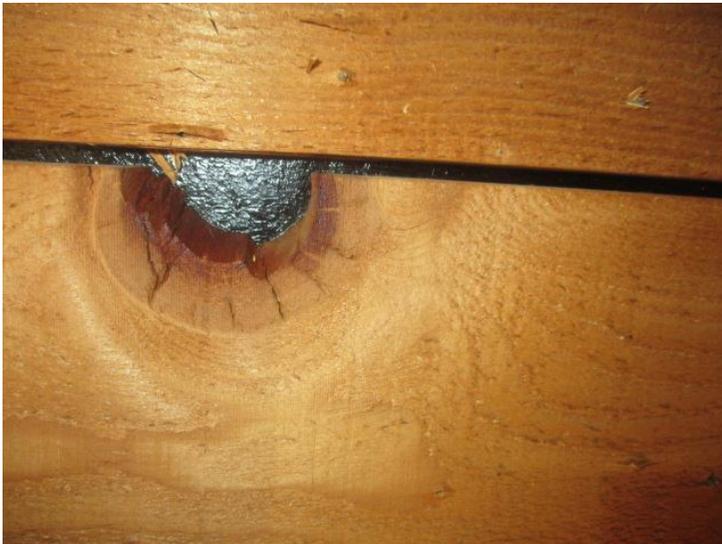
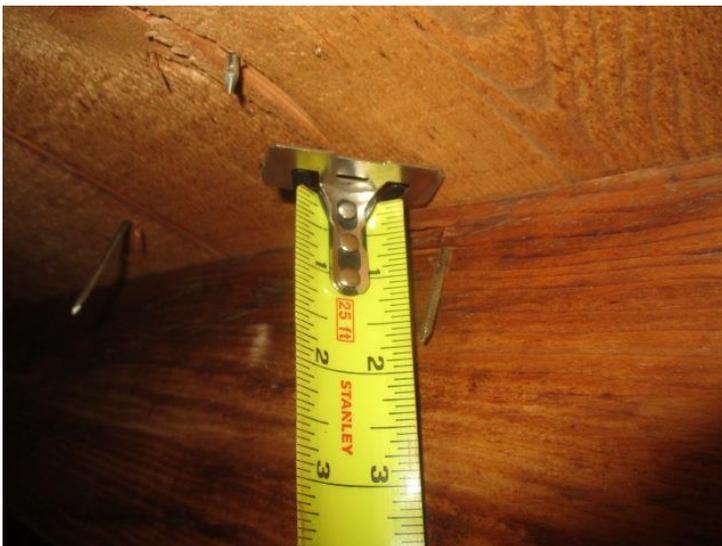
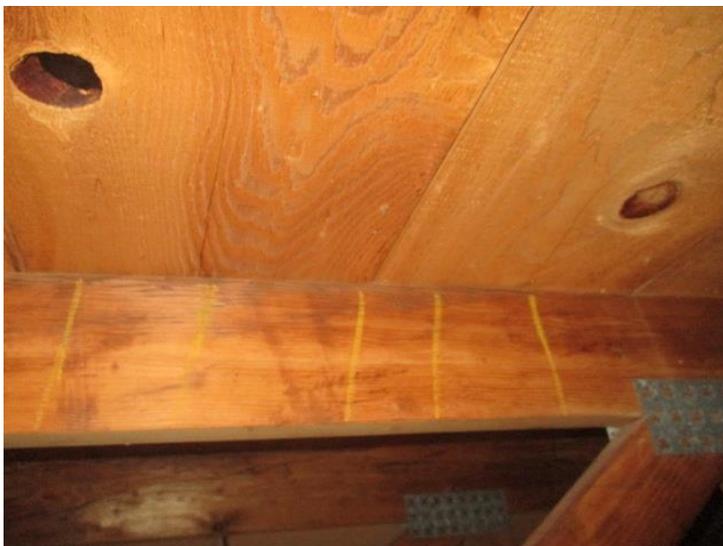
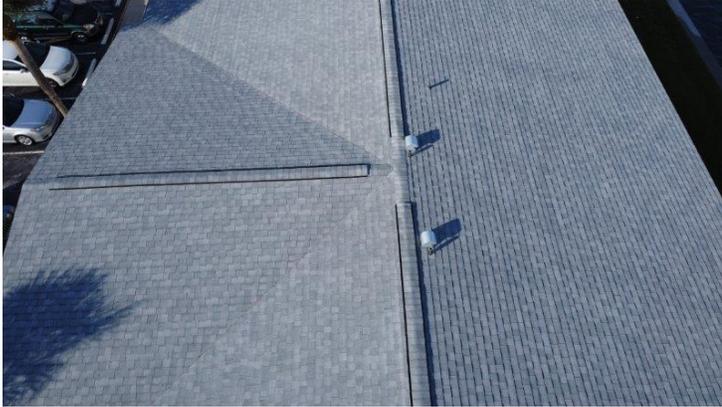
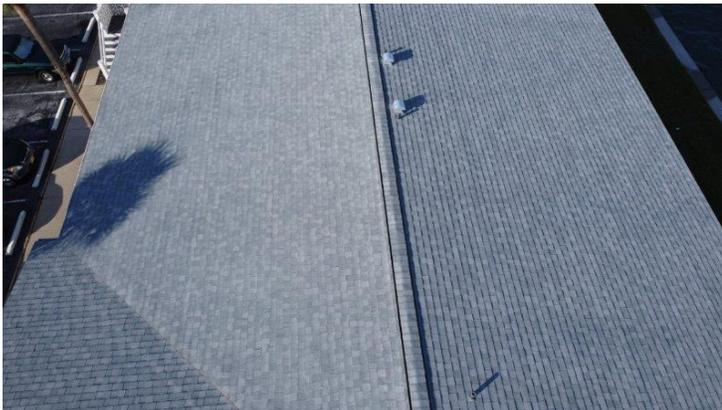
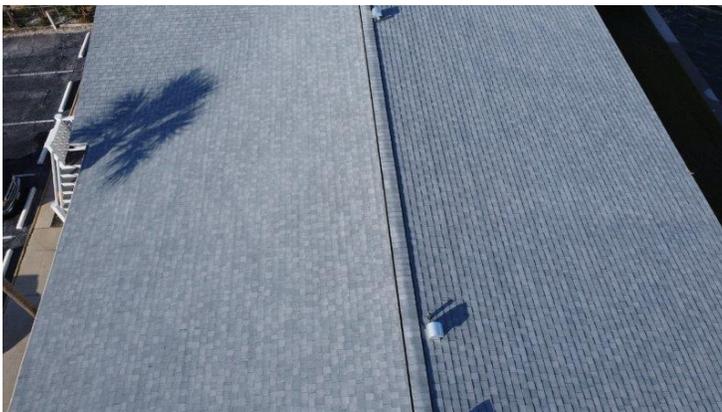
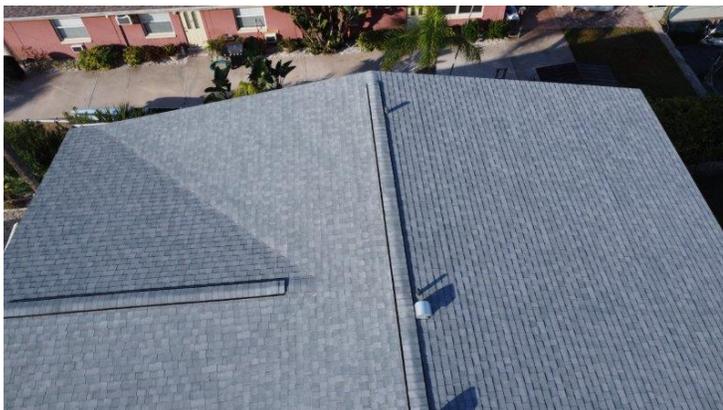
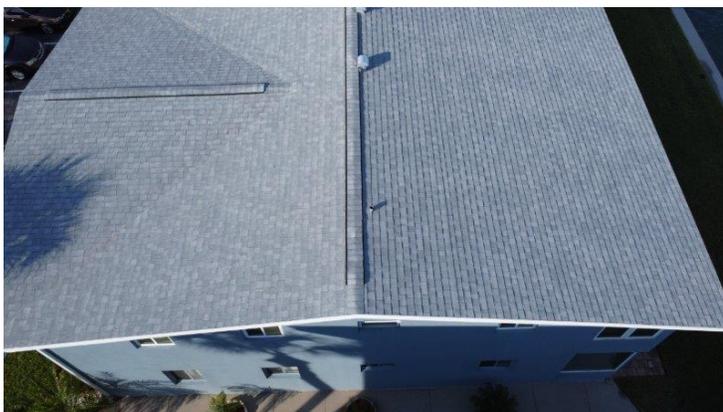
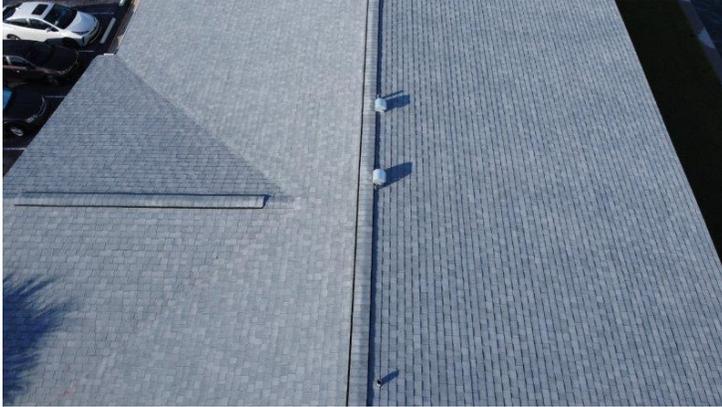
Roof Construction

- 3. Roof Deck Attachment:** **Level C**
Comments: Inspection verified skipped decking with a minimum of 2 nails per board.
- 4. Roof to Wall Attachment:** **Clips**
Comments: Inspection verified hurricane clips fastened with a minimum of three nails.

- 5. Roof Geometry:** **Other Roof**
Comments: Inspection verified a gable roof shape.
- 6. SWR:** **Yes**
Comments: SWR was verified at time of inspection. The Secondary Water Resistance verified is a self-adhering peel and stick.
